Path Summary Report

Dallas-DC (72.3.131.10) <-> www.apparenttools.com

May 12, 2009 - June 11, 2009

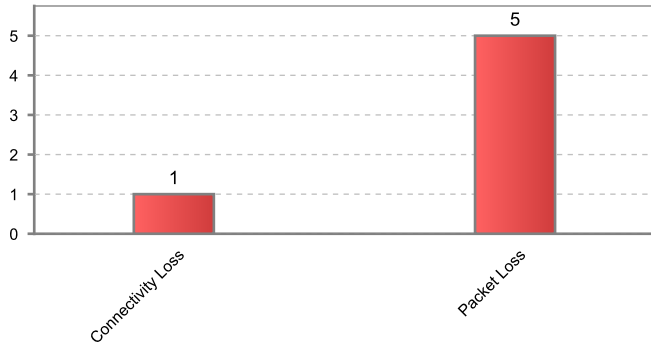
Number of Events

Service Quality Violations

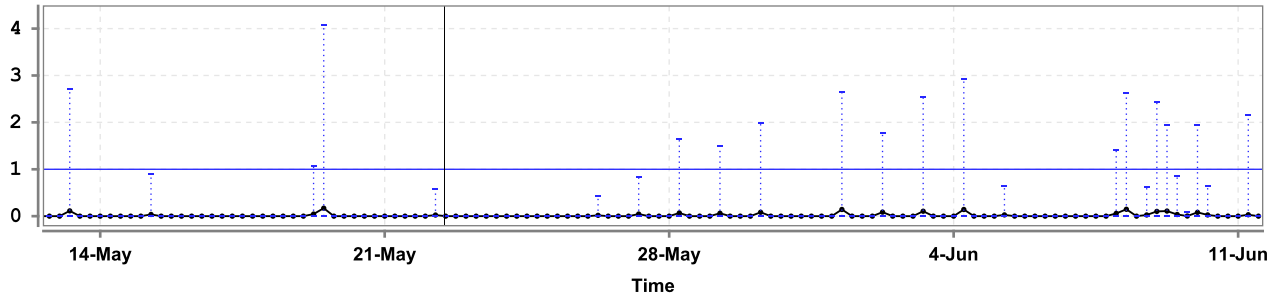
Packet Loss (%)

Chart Time: May 12, 2009 - Jun 11, 2009
